Live Load Distribution Factors and UHPC Shear Key Performance of SCDOT NEXT-D Beam

LIVE LOAD DISTRIBUTION FACTORS AND UHPC SHEAR KEY
PERFORMANCE OF SCDOT NEXT-D BEAM

A Thesis
Presented to
the Graduate School of
Clemson University

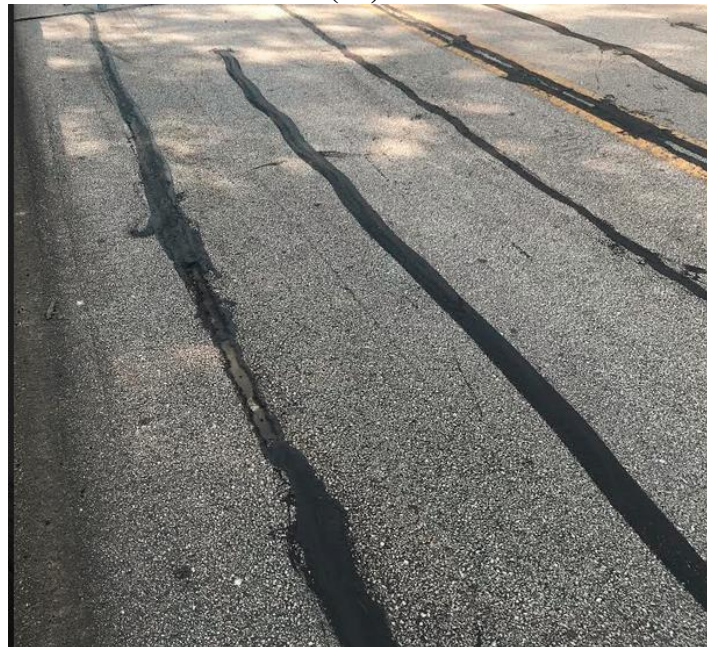
Figure 1: (1a) displays where cracks may form at the precast-shear key interface and (1b) displays reflective cracks and reflective crack patching

significantly reduces construction time. As beneficial as these girders can be to ABC, the shear keys connecting these girders can be problematic, sometimes even soon after construction. Cracks often form at the shear key-precaster interface as shown in figure 1a, which leads to longitudinal reflective cracks developing on the bridge deck as shown in figure 1b. Although initially these cracks are simple maintenance issues, they provide a route for water and deicing salts to access the mild reinforcement of the deck and girders and the pre-stressing strands of the girders.

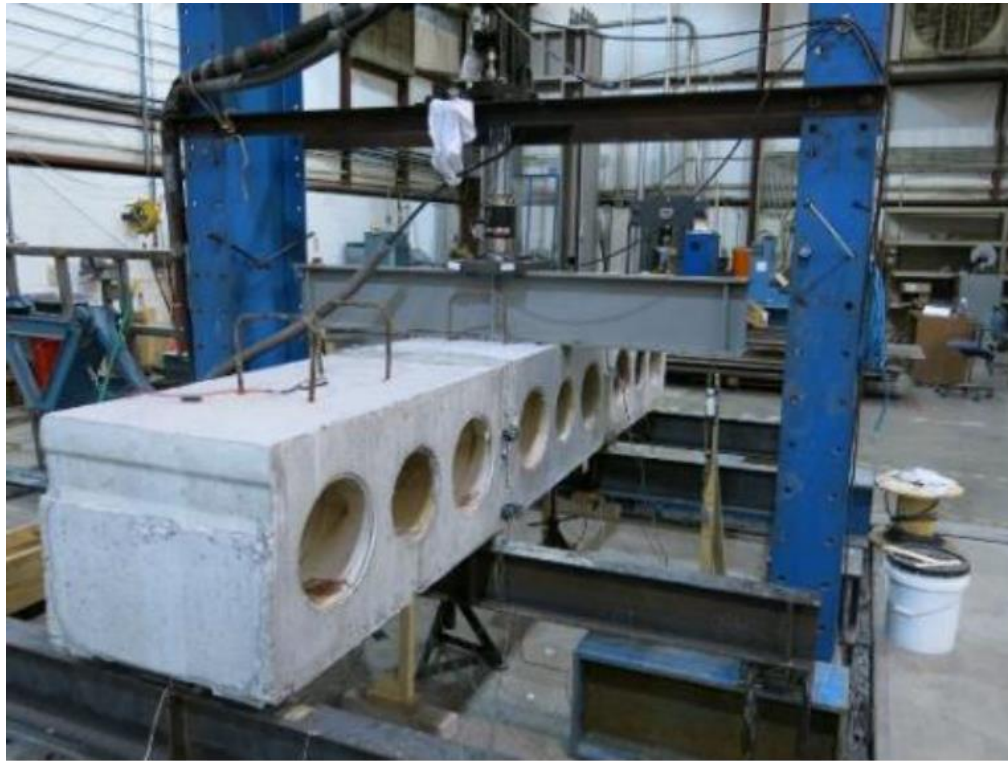
Figure 22: Typical SA test setup (Joyce, 2014)

Patrick Joyce (2014), a researcher at Virginia Tech, used SA tests to evaluate several girder-to-girder connection details' behavior and durability. The static behavior of the connections is discussed in this subchapter and the durability of the connections is discussed in the immediate following subchapter. Figure 22 shows the setup for a typical SA test.

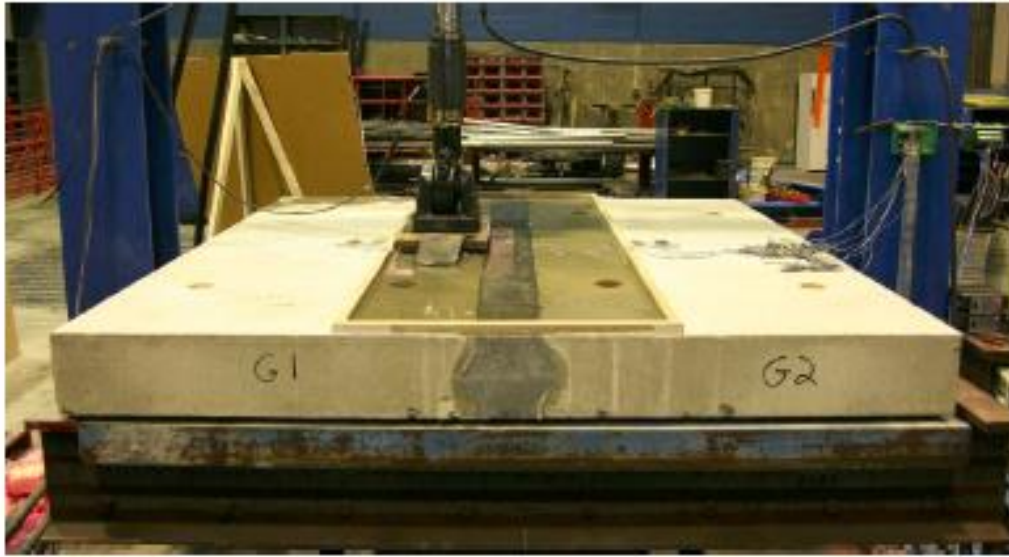
Figure 30: One of four transverse test specimens. G1 and G2 represent the two precast girders and the darker concrete between the two precast girders is the UHPC closure pour (Graybeal, 2010)

To complete the transverse testing, four test specimens were created with each specimen consisting of two precast panels connected transversely using NYSDOT connection details and UHPC as the closure pour. In figure 30 shown below, one test specimen set-up is displayed.

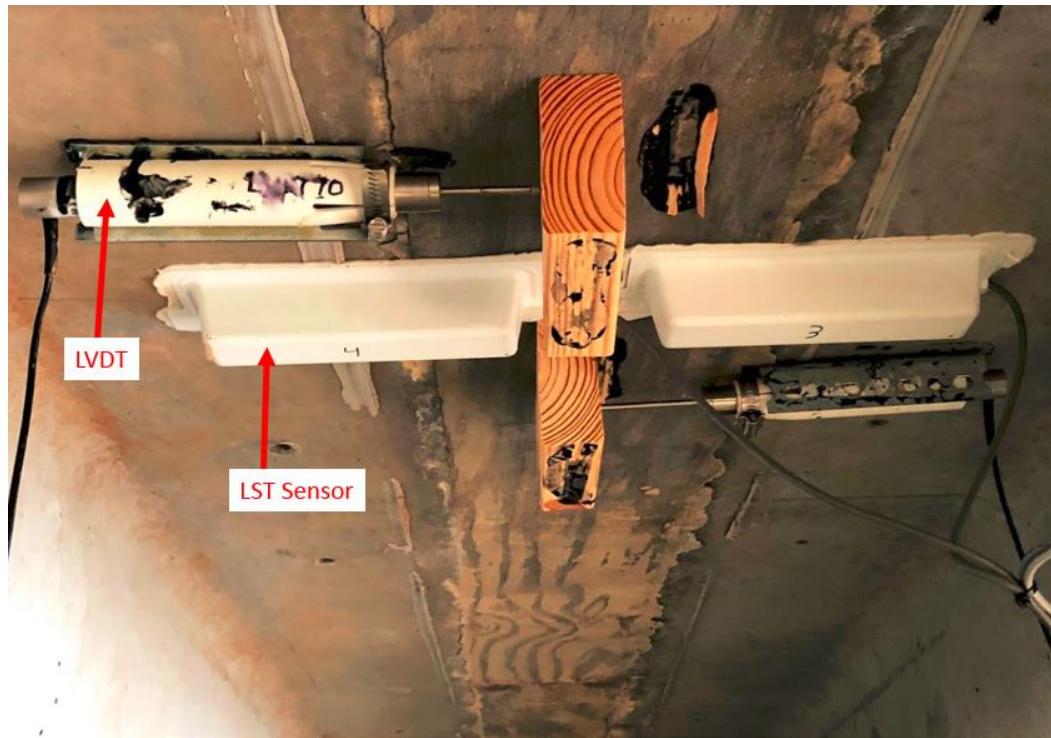
Figure 52: LVDT and LST Sensor attached at transverse joint of NEXT-D girders

attached by sticking the casing, with Loctite glue, to a girder surface. Before the casing was attached, accelerant was sprayed onto the glue that was applied to the LVDT casing so that researchers would not have to press the LVDT against the girder for a long period of time before it was secure. The LVDTs were attached near girder transverse joints so that the LVDT arm stretched over the transverse joint and made contact with a wood block that was glued to the adjoining girder. In this way, the LVDTs measured the horizontal displacement of a girder relative to its adjoining girder. The LVDTs were attached longitudinally at mid-span on both the NEXT-D and solid spans, which on the NEXT-D span placed the LVDTs directly next to LST sensors. The LVDT measurements were of importance because they provided insight to the condition of the UHPC shear key joints and provided data that allowed for a direct comparison to the LST data. A close-up of an attached LVDT next to a LST sensor is shown in figure 52. The transverse locations and orientation of the LVDTs used during the LL tests is discussed in further sub-chapters.

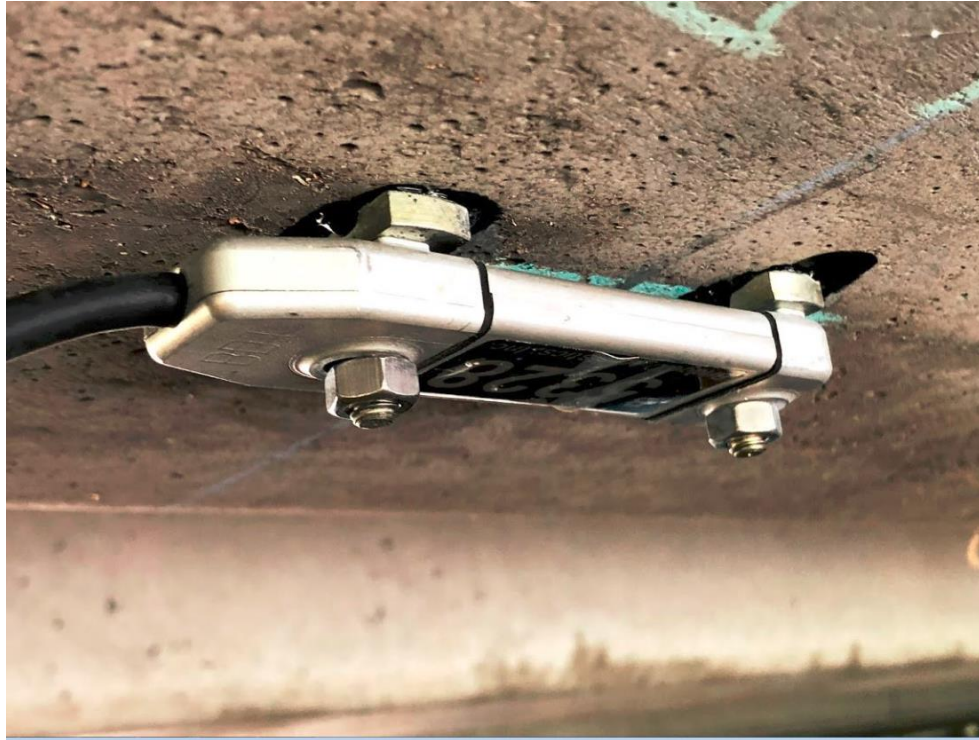
Figure 53: Strain transducer attached to a NEXT-D girder

a rosette orientation. The location and orientations of the strain transducers used during the LL tests is discussed in depth in further sub-chapters.

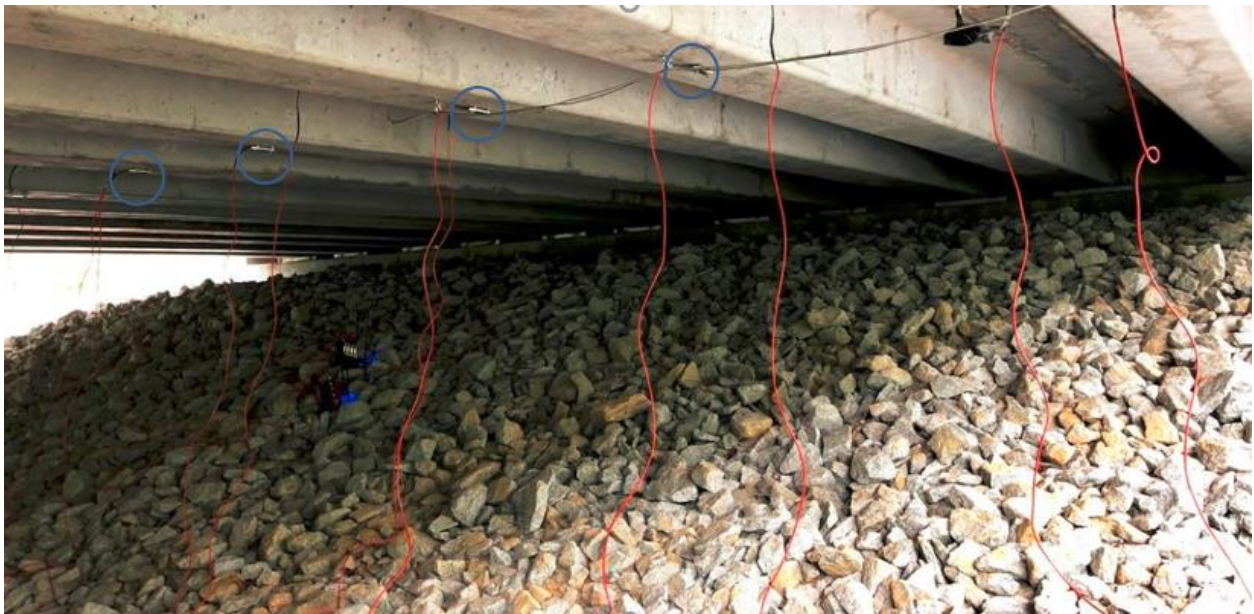
Figure 58: BDI strain transducers attached to the NEXT-D span

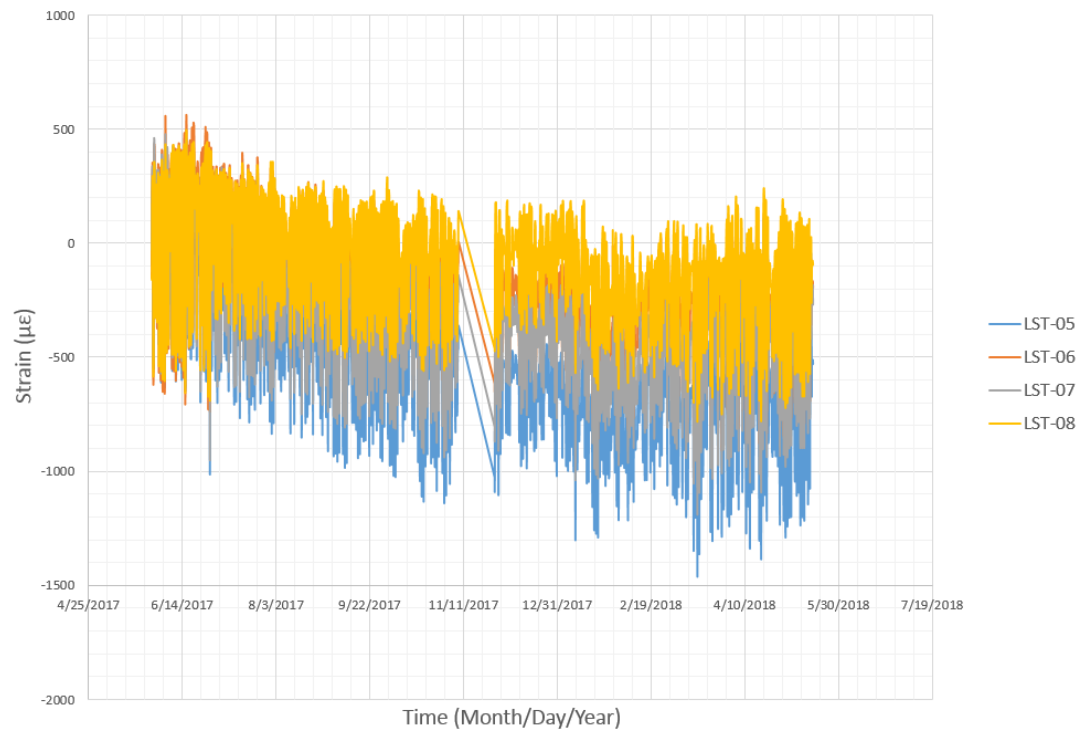
Figure 79: Voided span active strain data from May 27th 2017-May 15th 2018
